## 2008 INFINITI G37 JOURNEY

## Vehicle Inspection Report

Information		VIN #: JNKCV64E48M118160	Stock No : 0101
Motorized type:	CARS & TRUCKS & VANS	Body Style:	COUPE
Year:	2008	Doors:	2 DOORS
Make:	INFINITI	Top Style:	NOT SPECIFIED
Model:	G37	Interior Type:	LEATHER
Trim:	JOURNEY	Fuel Type:	GASOLINE
Free text:	3.7L V6 5-SPEED AUTO...	Engine:	3.7L V6
Title:	USED	Transmission:	5 SPEED AUTOMATIC
Title Status:	NOT SPECIFIED	Drive Type:	ALL WHEEL DRIVE
Titled In:	NOT SPECIFIED	Audio:	AM/FM/SATELLITE /CD
Odometer:	97,884 MI	Interior Color:	BLACK
Exterior Color:	GRAY

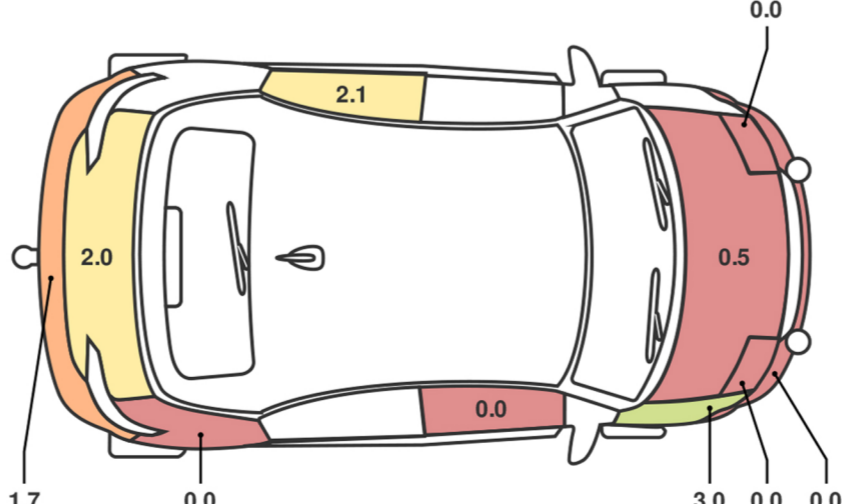
Right Fender	Dent/No Paint Dmg	10" or more	3.0	-	-	-	-	-	-	-
Images										
Right Quarter Panel	Collision Damage	10" or more	0.0	-	-	-	-	-	-	-
Images										
Deck Lid	Scratch Heavy	10" or more	2.0	-	-	-	-	-	-	-
Images										
Right Front Door	Collision Damage	10" or more	0.0	-	-	-	-	-	-	-
Images										
Left Rear Door	Dent/Paint Dmg	6" to 7"	2.1	-	-	-	-	-	-	-
Images										
HeadLight	Broken	replacement required	0.0	-	-	-	0.25	0.5	-	52.50
Images										
<b>Subtotal of Exterior Cost: \$52.50</b>				-	-	-	0.25	0.50	-	52.50

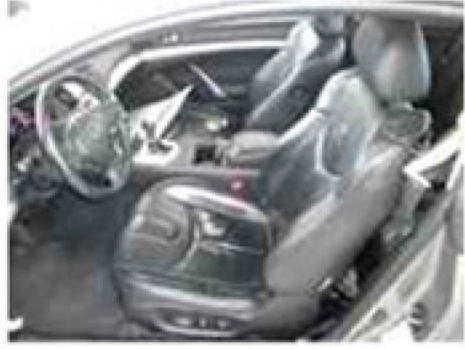
Interior	Right Front Seat	worn	9" to 10"	4.1	-	-	-	-	-	-	
Images
